Installation Instructions For 2012-2016 BMW F10/F11 520i 528i (N20)

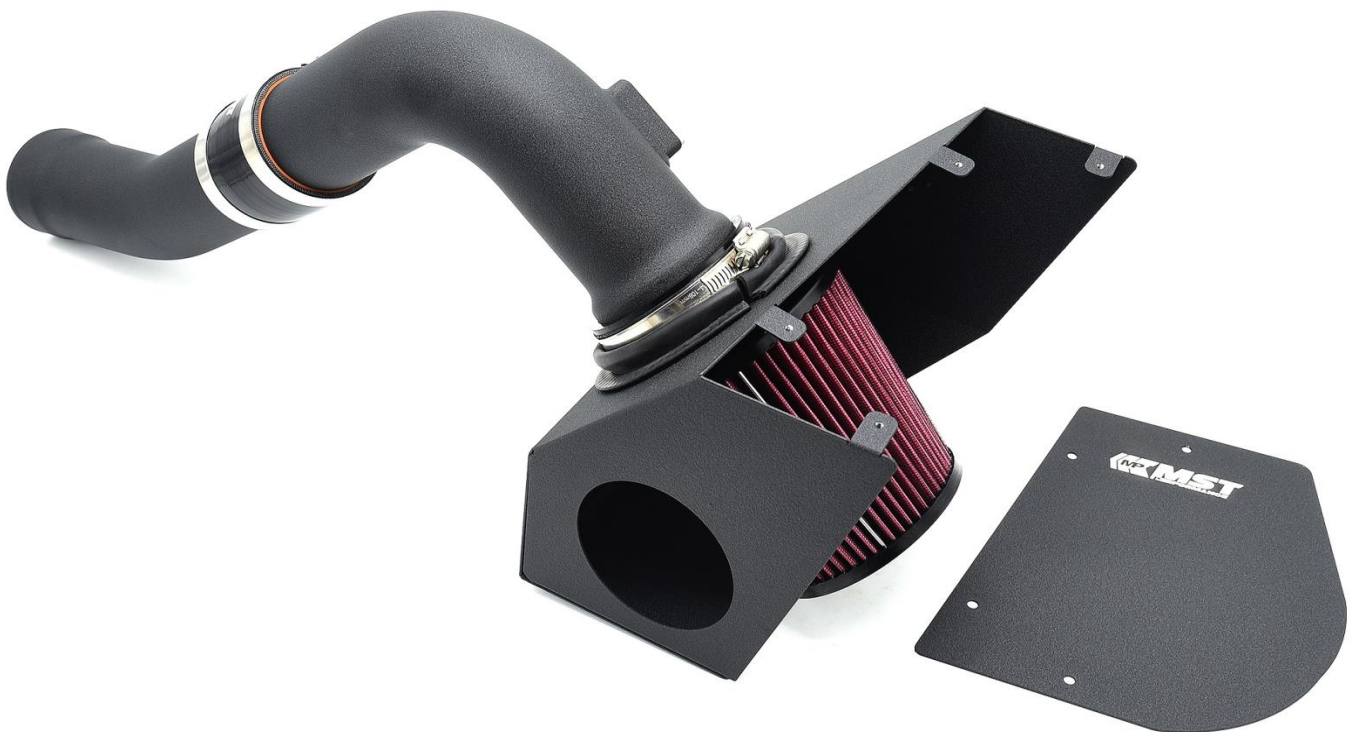
KIT CONTENTS

| NO. | DESCRIPTION | QTY |
| 1 | Intake Pipe A | 1 |
| 2 | Intake Pipe B | 1 |
| 3 | Heat Shield | 1 |
| 4 | Heat Shield Cover | 1 |
| 5 | M4 Bolt 6mm | 4 |
| 6 | M4 Spring Washer | 4 |
| 7 | M4 Washer | 4 |
| 8 | M4 Bolt 8mm | 2 |
| 9 | 76-76 Silicone Hose | 2 |
| 10 | Clamps | 2 |
| 11 | Air Filter 89/145mm | 1 |

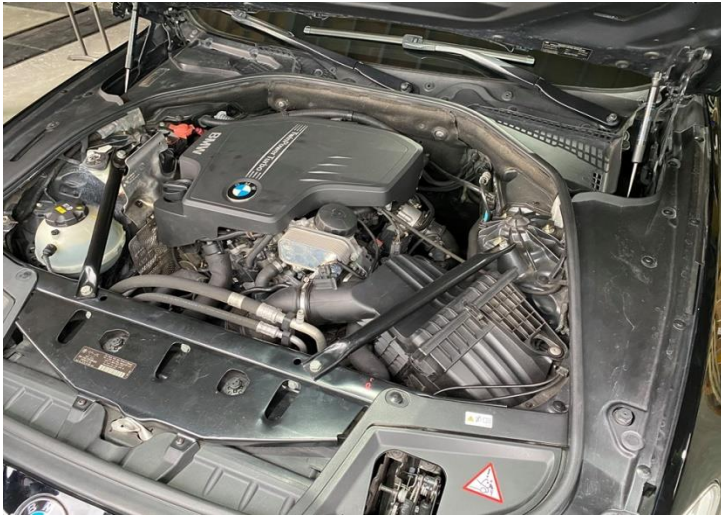
Figure 1: Stock air box.

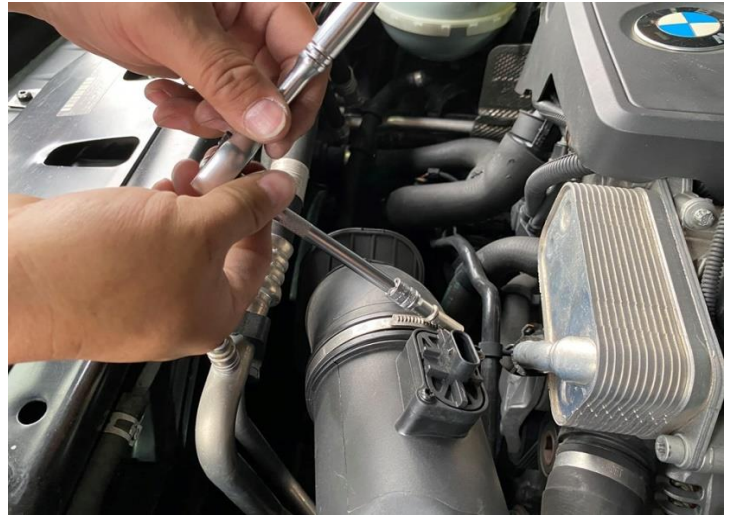
Figure 4: Loosen the stock tube clamp.

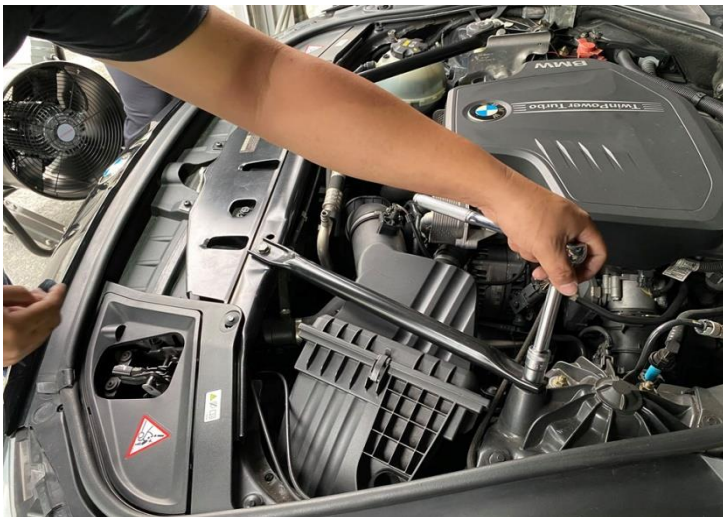
Figure 2: Remove the strut bar.

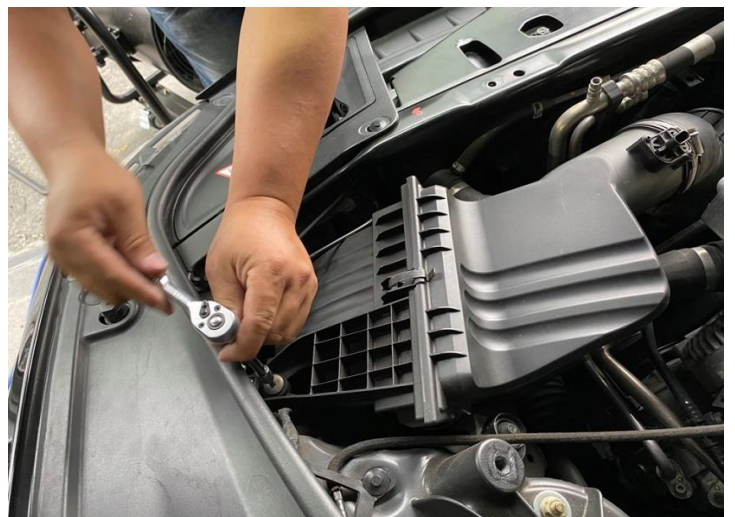
Figure 5: Remove the air box bolt.

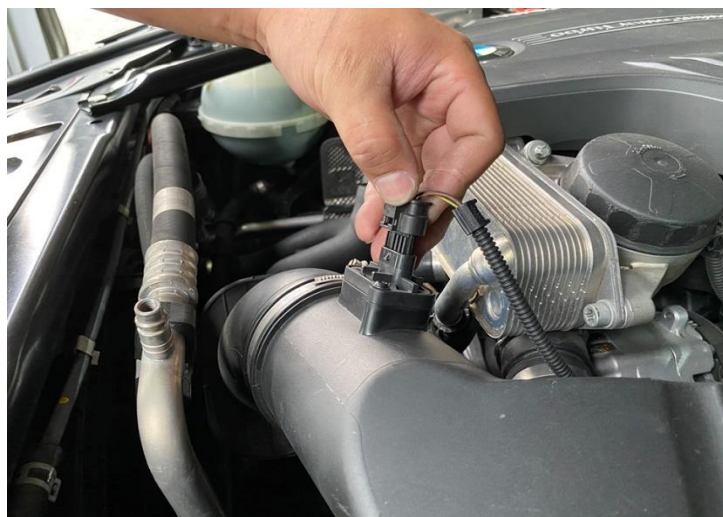
Figure 3: Disconnect the MAF sensor.

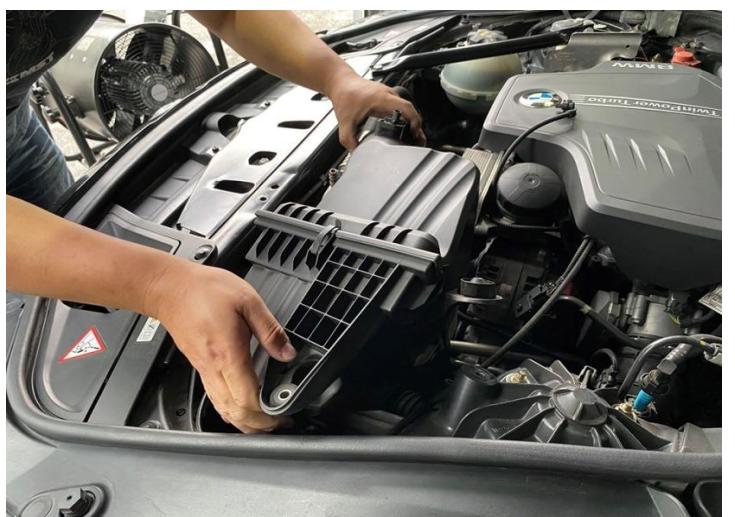
Figure 6: Remove the stock air box.

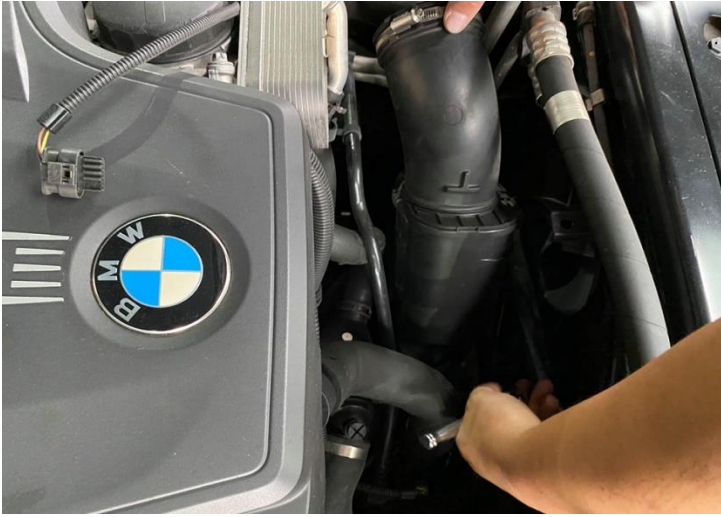
Figure 7: Remove the stock tube.

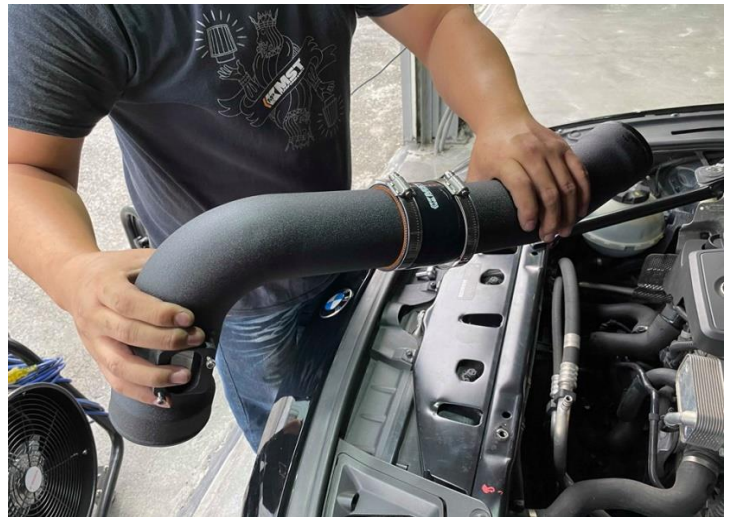
Figure 11: Install the intake pipe.

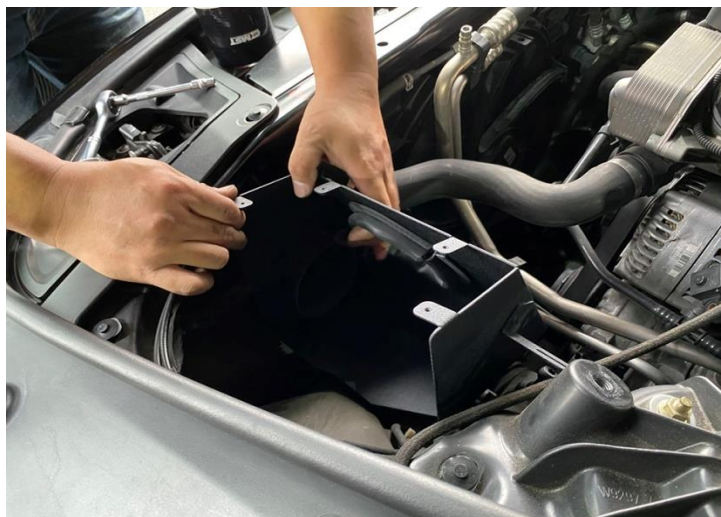
Figure 9: Install the heat shield.

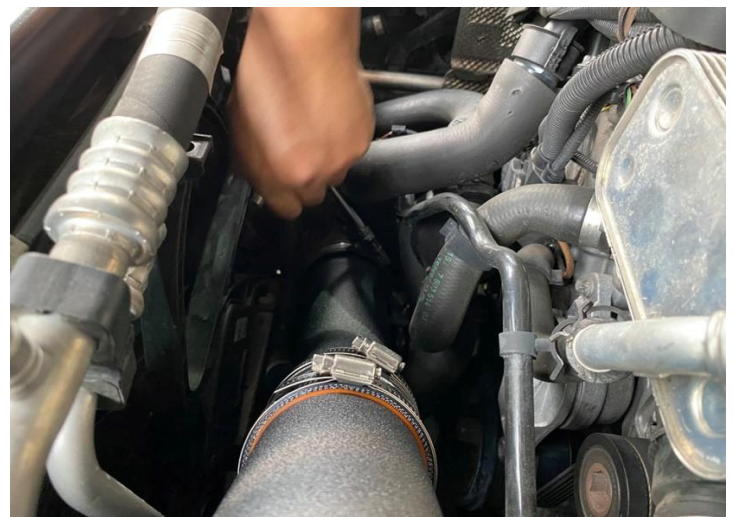
Figure 12: Tight the clamp.

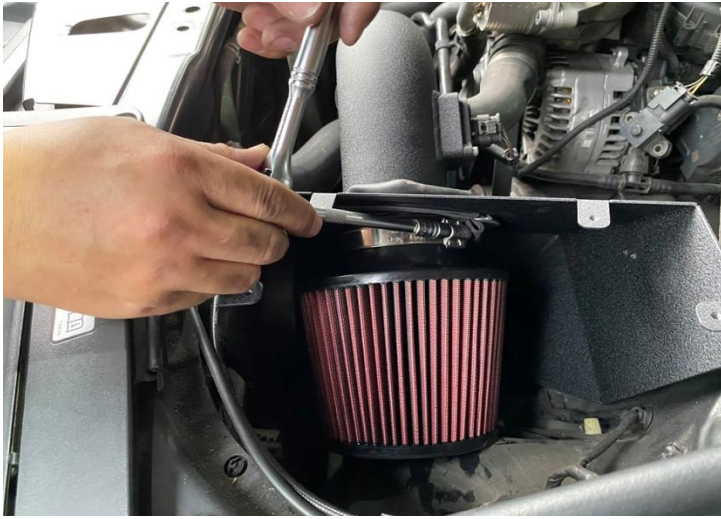
Figure 13: Install the air filter.

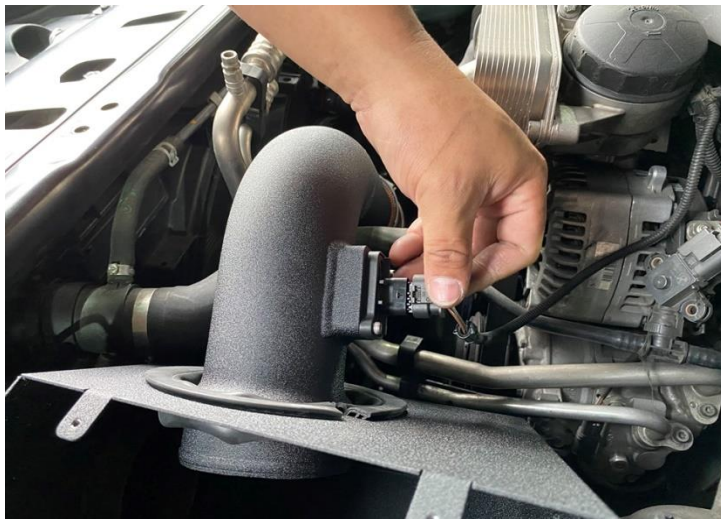
Figure 14: Connect the MAF sensor.

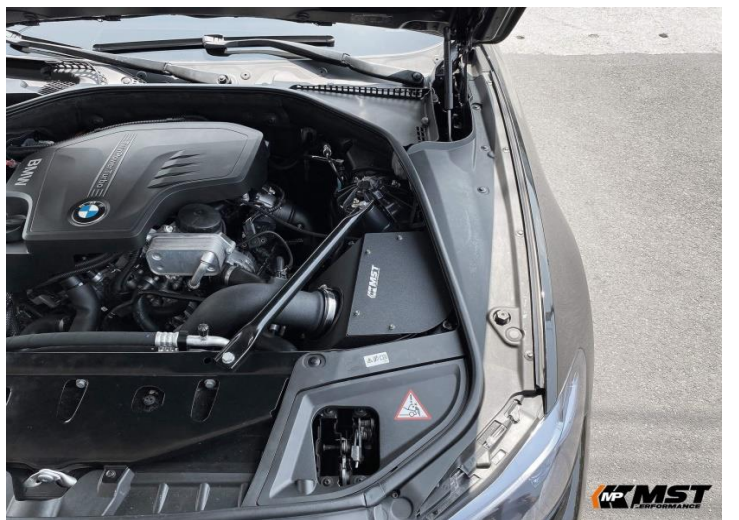
Figure 17: Congratulations! You have just completed the installation of this intake system. Periodically, check the alignment of the intake, normal wear and tear can cause nuts and bolts to come loose.

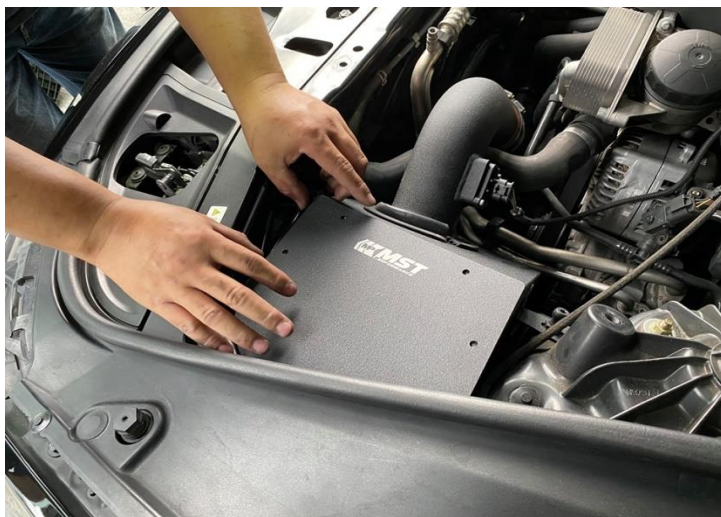
Figure 15: Install the heat shield cover.
